Pilot's Inadequate Altitude Monitoring During Instrument Approach Led to CFIT

The pilot hand-flew an unstabilized approach below the glideslope and continued the descent until the Piper Chieftain struck terrain. New Zealand investigators cited high workload and possible distraction by a cellular telephone call as factors in the controlled flight into terrain.

—
FSF Editorial Staff

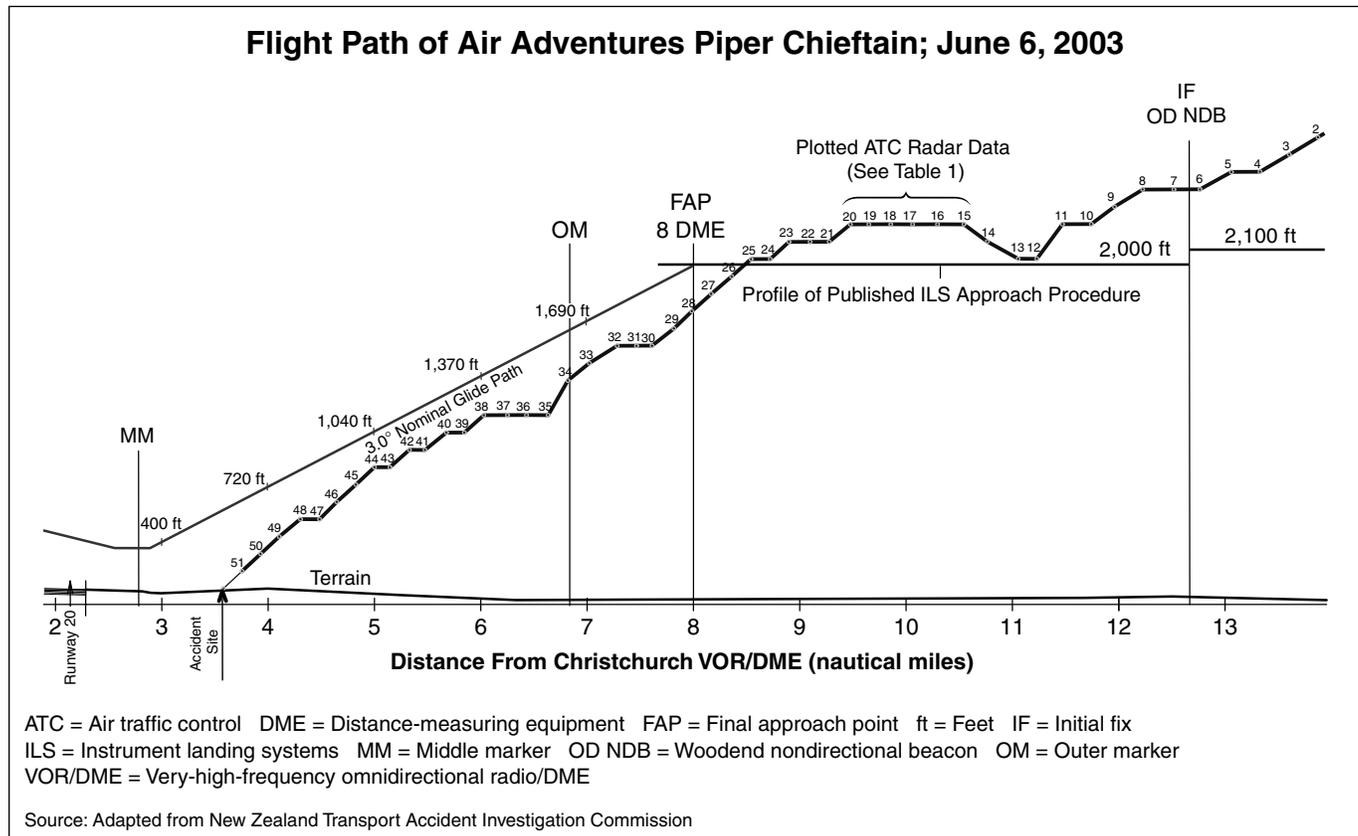
Figure 1

The published ILS procedure indicated that glideslope interception would occur at 2,000 feet and 5.7 nautical miles (10.6 kilometers) from the runway threshold. The pilot began the descent from 2,000 feet about 6.2 nautical miles (11.5 kilometers) from the runway threshold (Figure 1; Table 1, page 5). The aircraft then was flown 200 feet to 300 feet below the glideslope for the remainder of the flight.

“The aircraft’s descent, which began before reaching the glideslope and continued below the glideslope, resulted either from a faulty glideslope indication or from the pilot flying a localizer approach instead of an ILS approach,” the report said. [The published procedure for the localizer approach included a descent from 2,000 feet to 720 feet, beginning 5.7 nautical miles from the runway threshold, and a further descent to 470 feet, the minimum descent altitude, beginning at the outer marker.]

Table 1
Air Traffic Control Radar Data; Air
Adventures Piper Chieftain; June 6, 2003
(As Plotted in Figure 1)
