Boeing 737 Pilot Flying Selects Incorrect Altitude in Holding Pattern, Causes Dangerous Loss of Separation with MD-81

The B-737 pilot correctly read back an ATC clearance, but set the wrong flight level in the autopilot mode control panel. Separation between the B-737 and a McDonnell Douglas MD-81 in the same holding stack was reduced to less than one-half mile (0.8 kilometer) horizontally and 100 feet (30.5 meters) vertically at their closest.

FSF Editorial Staff

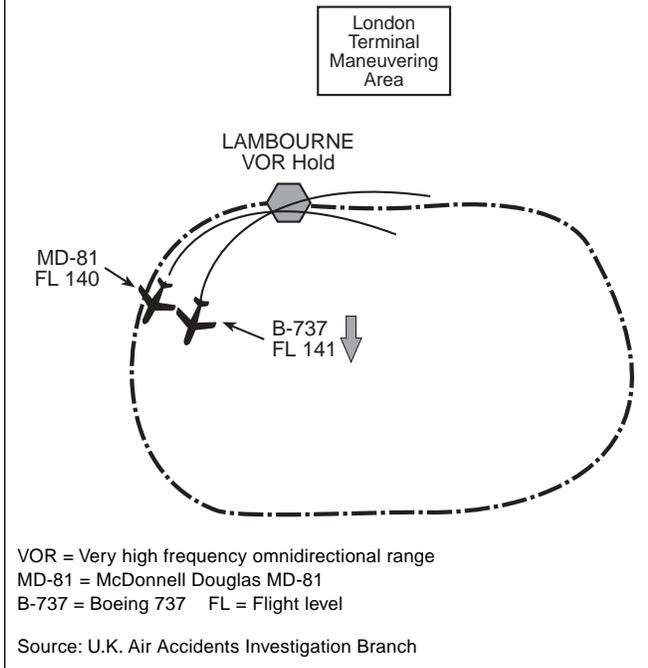
Figure 1

At 1643:18, when the B-737 reported entering the hold at LAM, it was 700 feet directly above the MD-81. The two aircraft turned left together in the holding pattern (Figure 1, page 3).

**AIRPROX, Lambourne Sector,
London Air Traffic Control Centre,
Nov. 12, 1996**

“The B-737 had executed a slightly smaller-radius turn than the MD-81, which resulted in the B-737 being slightly ahead and to the left of the MD-81 at the time of the closest proximity, with both aircraft having left bank applied for the turn, about 25 degrees in the case of the B-737,” said the report.
