Boeing 747 In-flight Breakup Traced to Fuel-tank Explosion

Investigators concluded that a flammable mixture of fuel and air in the center-wing fuel tank likely was ignited by voltage from an external short circuit that was conducted into the tank by electrical wiring associated with the fuel quantity indication system.

—
FSF Editorial Staff

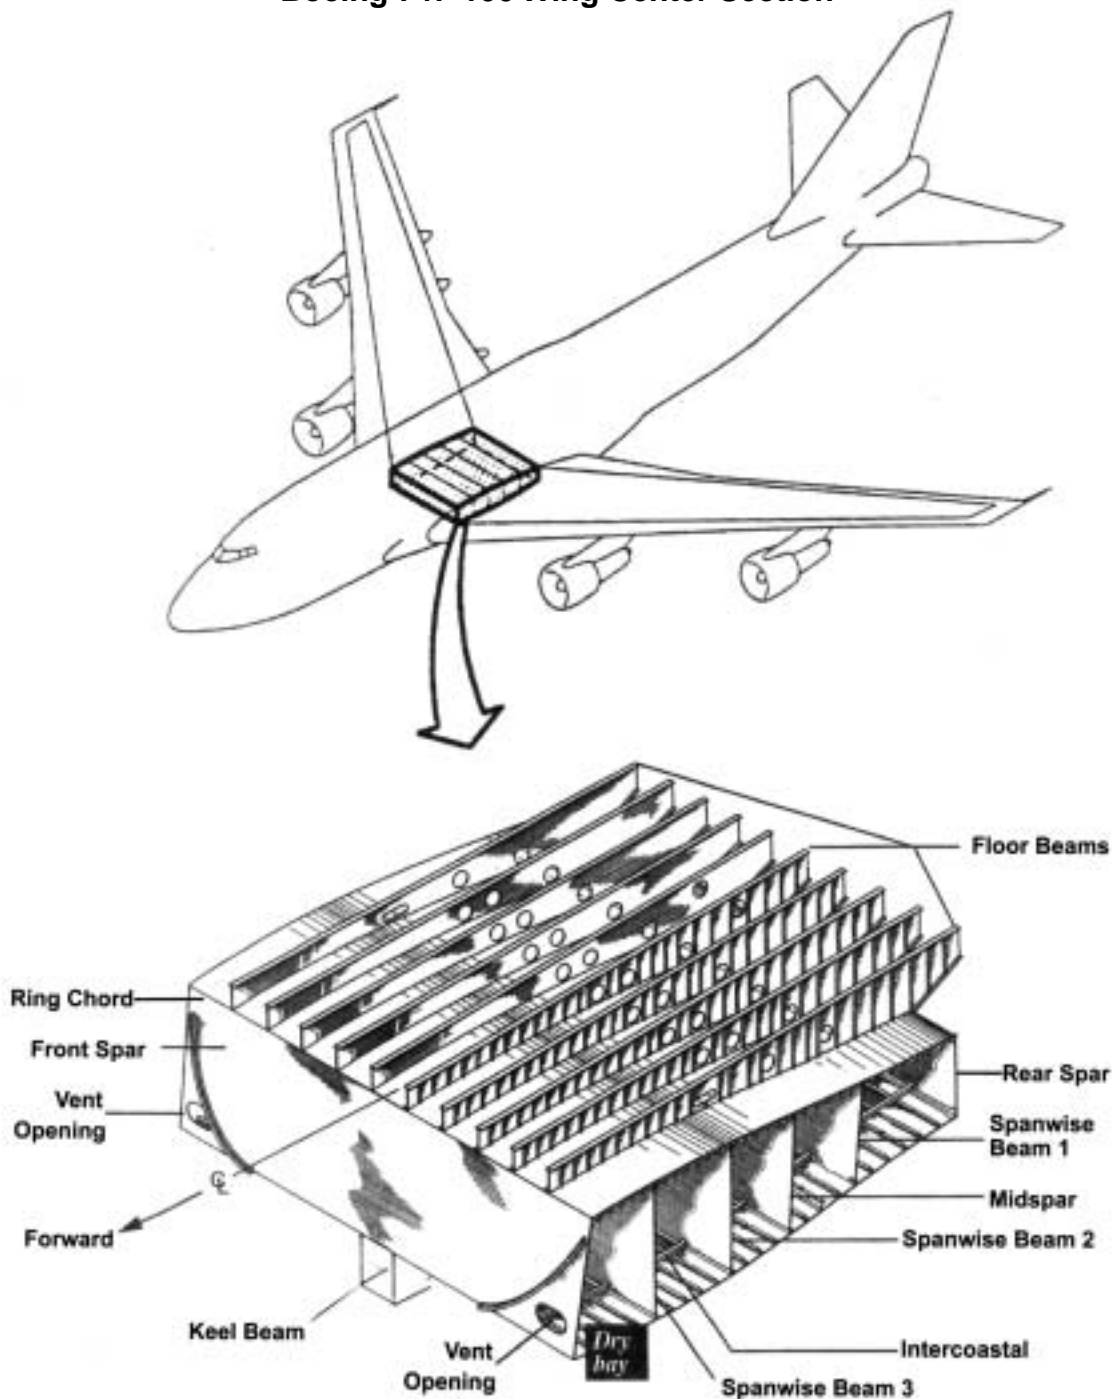
Figure 1

Boeing 747-100 Wing Center Section
