# Aviation Investigation Final Report

| <b>Location:</b> | Heyburn, Idaho | <b>Accident Number:</b> | WPR22FA151 |
| <b>Date &amp; Time:</b> | April 13, 2022, 08:32 Local | <b>Registration:</b> | N928JP |
| <b>Aircraft:</b> | Cessna 208B | <b>Aircraft Damage:</b> | Substantial |

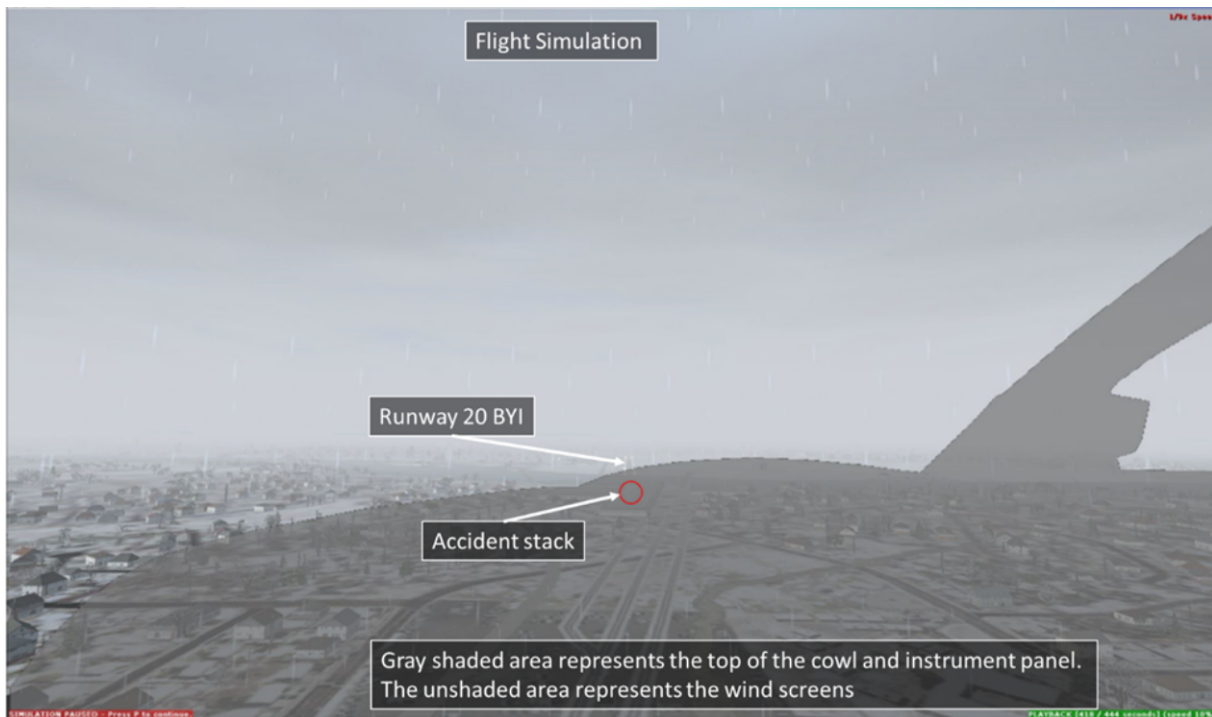
*Figure 4. Flight simulation using accident weather conditions and airplane attitude, showing the airport visible above the instrument panel while the stack is concealed by the instrument panel.*

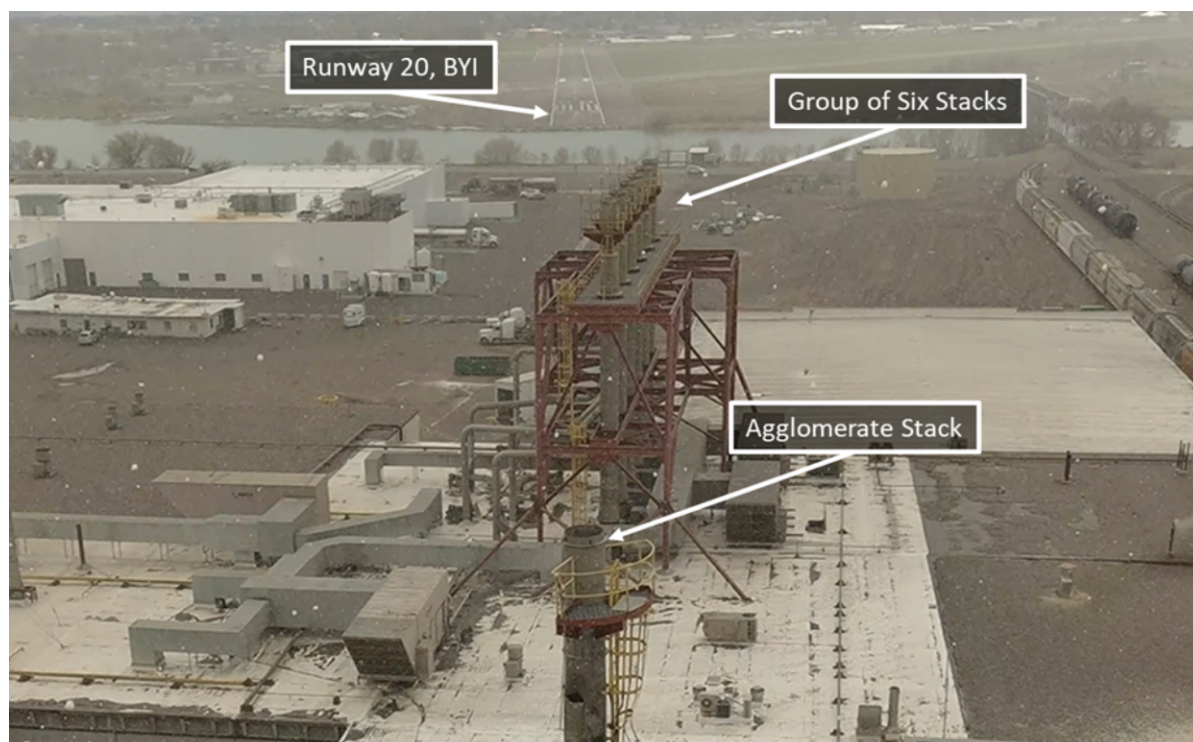
The existing paint scheme and the visible moisture emitted by the stacks provided a low contrast to the environmental background. This low contrast and the lack of a visual glide slope indicator may have caused difficulty for the pilot in maintaining a safe altitude during the visual portion of the approach to the runway. A white and aviation orange paint scheme, as identified in the regulations, may have offered a higher contrast and thus an adequate warning once the pilot transitioned to visual conditions.

*Figure 9. Image of the Gem State Processing plant roof top. The agglomerate stack and the group of six stacks are in view. Photo courtesy of the Hayburn Police Department.*

The NTSB asked for clarification as to whether the stacks in question were required to be both marked and lighted in accordance with FAA Advisory Circular 70/7460-1. The FAA confirmed that “as a condition of the No Hazard Determination, dated February 2, 2017, the stacks were required to be painted with white and aviation orange paint, and lit with red obstruction lights, per FAA Advisory Circular 70/7460-1.” The NTSB noted during the investigation that neither the agglomerate stack nor the six drum dryer stacks were painted with white and orange aviation paint. Each stack in the group of six stacks had a red aircraft warning light.
