Boeing 737 Pilot Flying Selects Incorrect Altitude in Holding Pattern, Causes Dangerous Loss of Separation with MD-81

The B-737 pilot correctly read back an ATC clearance, but set the wrong flight level in the autopilot mode control panel. Separation between the B-737 and a McDonnell Douglas MD-81 in the same holding stack was reduced to less than one-half mile (0.8 kilometer) horizontally and 100 feet (30.5 meters) vertically at their closest.

FSF Editorial Staff

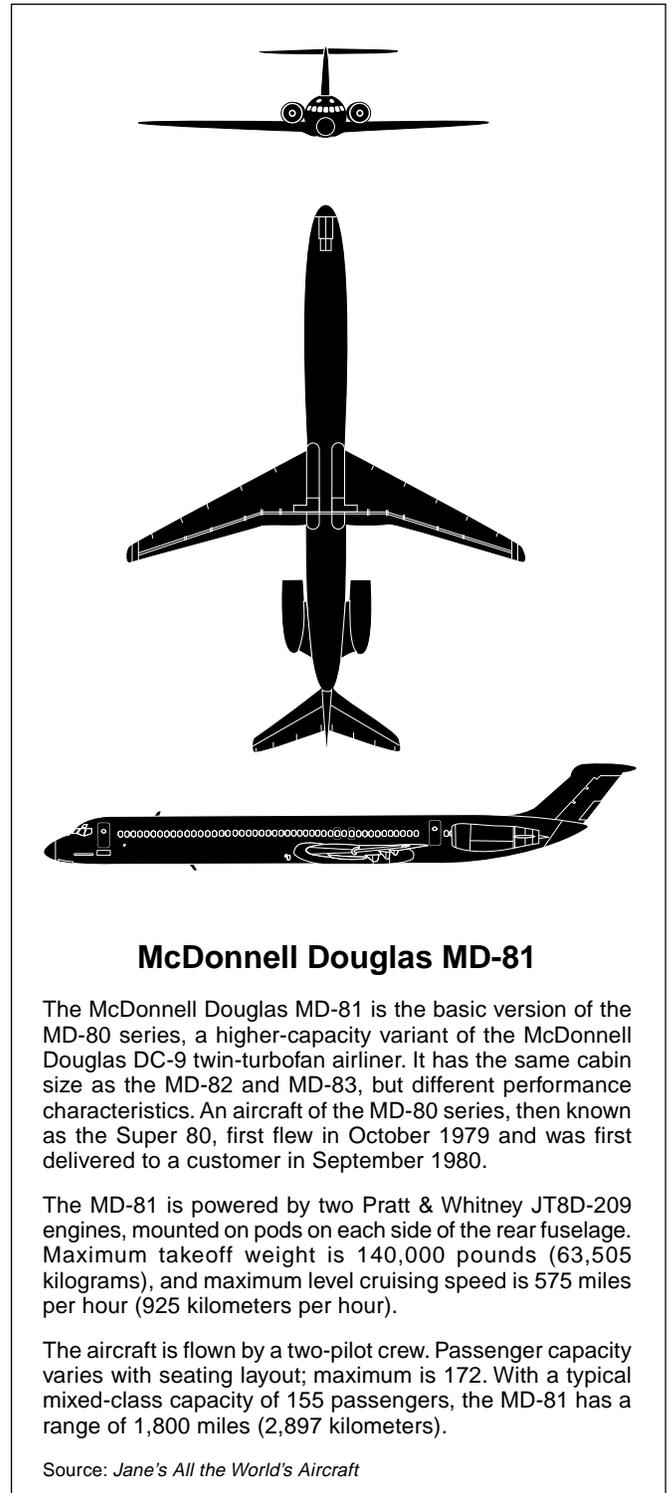
and between 2,231 feet and 2,690 feet horizontally, from 1643:54 to 1643:59.

“The B-737 had executed a slightly smaller-radius turn than the MD-81, which resulted in the B-737 being slightly ahead and to the left of the MD-81 at the time of the closest proximity, with both aircraft having left bank applied for the turn, about 25 degrees in the case of the B-737,” said the report.
