# Aviation Investigation Final Report

| <b>Location:</b> | Heyburn, Idaho | <b>Accident Number:</b> | WPR22FA151 |
| <b>Date &amp; Time:</b> | April 13, 2022, 08:32 Local | <b>Registration:</b> | N928JP |
| <b>Aircraft:</b> | Cessna 208B | <b>Aircraft Damage:</b> | Substantial |

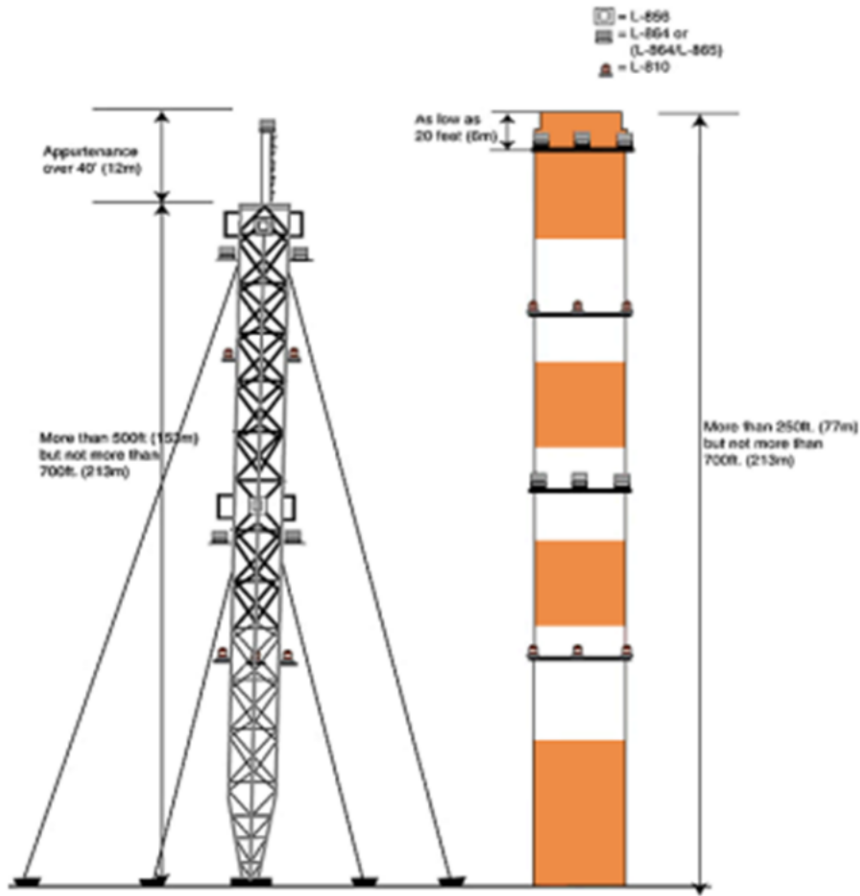
The second survey determined the agglomerate stack, and the row-of-six stacks exceeded the CFR section 77 standards and provided mitigating actions the processing plant must take for the stacks to receive a determination of no hazard to air navigation. One of the mitigating actions was that the stacks be painted in accordance with Advisory Circular AC 70/7460-1, which detailed a color scheme of high visibility white and aviation orange and that the stacks be equipped with red flashing warning lights. The control measures also included the permanent removal of the VASI. On the day of the accident, the agglomerate and row-of-six stack support structures were painted a red oxide color with yellow handrails. This color scheme was detailed to the FAA in an electronic message from Gem State dated August 17, 2017. Postaccident visual examination by the IIC confirmed the warning lights were installed, and five of the row-of-six stack warning lights were confirmed to flash and were red in color.

Figure 8. FAA Advisory Circular 70/7460-1K illustration showing an exhaust stack painted white and aviation orange.
