Aviation Mechanics Bulletin

NOVEMBER–DECEMBER 2004

Improper Inflation Cited in Six Tire-failure Incidents

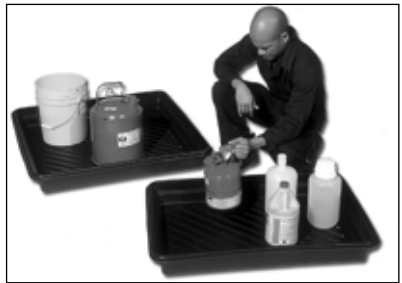
Utility Trays

The ribbed bottoms of Ultra-Utility Trays are designed to elevate containers above any spillage or leakage, as well as to prevent fluids from forming a slippery or damaging residue on the shop floor.

The trays, manufactured from polyethylene, are stackable for storage. The product is available in five sizes, from 12 inches by 48 inches by 4.75 inches (30 centimeters by 122 centimeters by 12 centimeters) to 36 inches by 36 inches by 4.75 inches (91 centimeters by 91 centimeters by 12 centimeters) inside diameter.

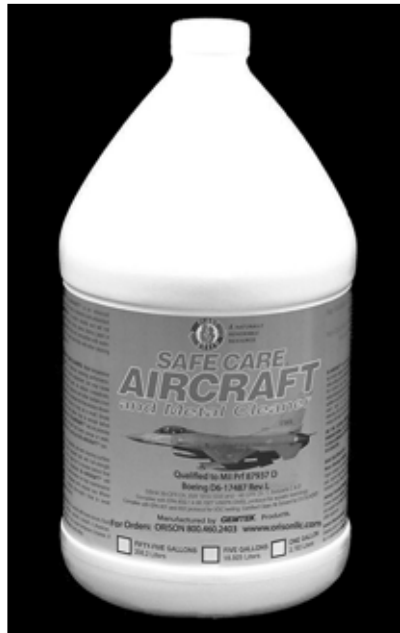
Aircraft and Metal Cleaner

The cleaner's formula is readily biodegradable, does not react with other chemicals to create hazardous conditions and requires no personal protective equipment or handling precautions, the manufacturer says. It is nonflammable and can be stored indefinitely.

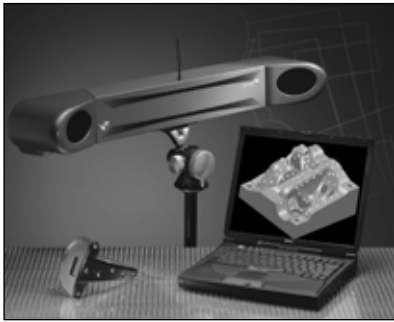
Coordinate-measurement Machine

Actiris350 is a coordinate-measurement machine quality-control system that checks the dimensional and geometric accuracy of parts, equipment or complex machinery. The unit is portable, weighing 37.5 pounds (17 kilograms), and the absence of wires between its lightweight probe and the measurement device allows the user freedom of movement.

The technology is based on a combination of advanced photogrammetry (the science of obtaining reliable measurements by photography) and digital-image processing. The manufacturer says that Actiris350 provides accurate results combined with speed of measurement.

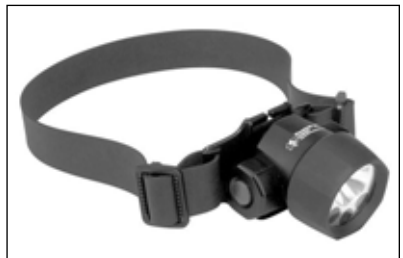
Personal Lighting System

A hands-free personal lighting system, the HeadsUp Lite series from Pelican uses light-emitting diodes (LEDs) and offers three brightness levels and a flashing mode. The LED module is powered by three “AA” alkaline batteries housed in a separate, strap-mounted o-ring pack, and a battery indicator displays the battery status. One set of batteries provides three hours of light at 100 percent power and 24 hours of light at 25 percent power.

The cloth and rubber straps are designed to adjust easily so that the light and battery pack fit comfortably on the user’s head, with the battery pack

positioned at the back to provide balance. The lighting head pivots to direct the beam. The unit weighs 0.4 pounds (0.19 kilograms).
